## **Fort Leonard Wood Lake of the Ozarks Recreation Area, NRHP Section 110 Inventory and Evaluation**

Sunny E. Adams and Adam D. Smith

June 2016

Final report

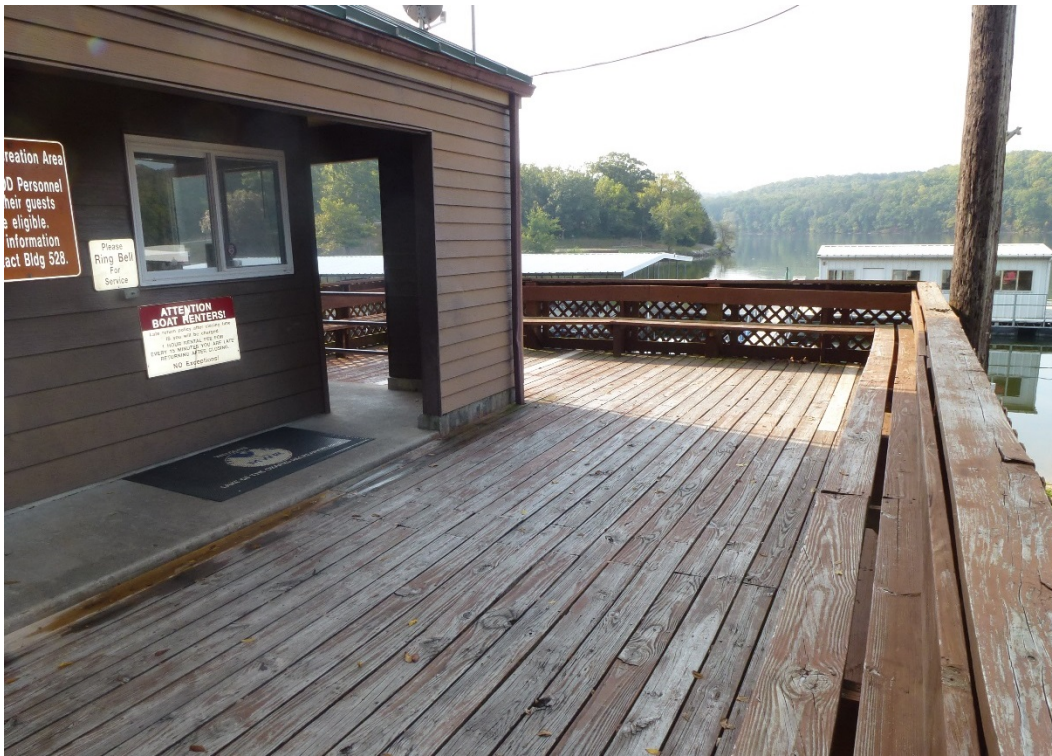
Figure 42. Wood deck addition surrounding the Building 528 on the east, south, and west sides (ERDC-CERL, 2015).

Building 528 is set within the slope of a hill. The raised concrete foundation is visible on the south side of the building (Figure 41). A poured concrete walkway encompasses the building on the east, south, and west sides. A set of poured concrete steps lead off the south elevation down to the marina. A wood-framed deck wraps around the building the left side of the south elevation and the west sides (Figure 42).

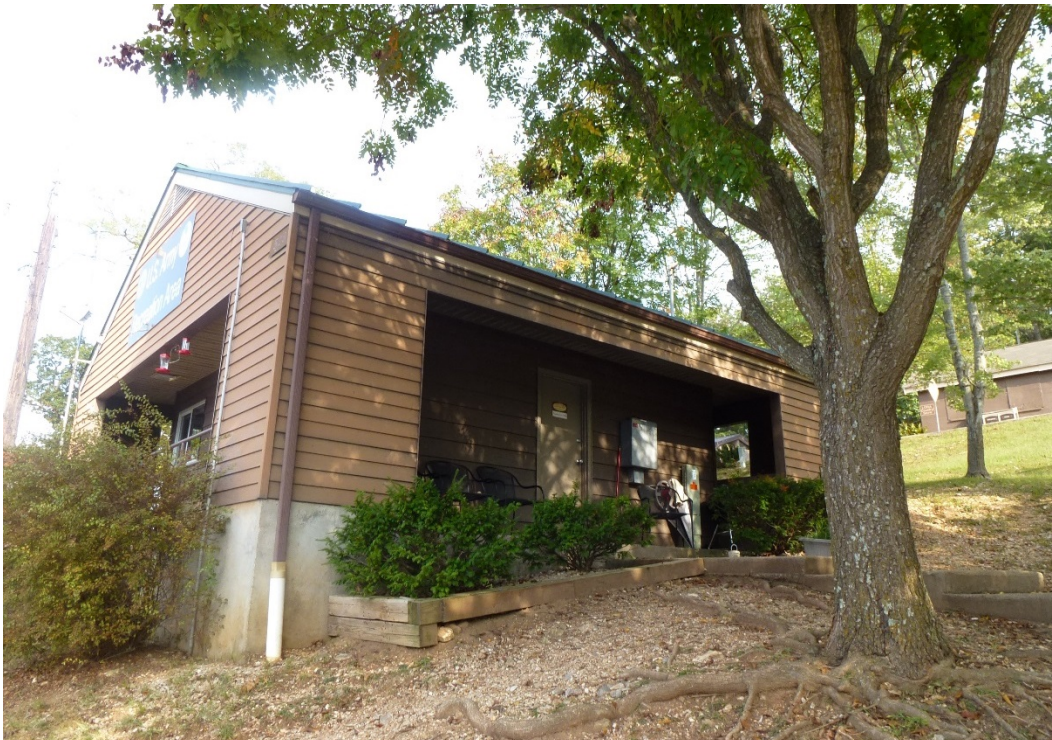
Figure 43. Gable roof that extends out to protect the incised concrete walkway of Building 528 (ERDC-CERL, 2015).

The building is a one-story rectangular building with a gable roof that protects an incised concrete walkway around the edge of the building. The overhanging gable is supported at the corners (Figure 43). The building is clad with newer metal siding. The vertical supports of the gable overhang are clad in a different metal siding. The building has a newer metal roof. The windows are a mixture of one-over-one and paired slider windows. The south elevation faces the marina and lake. There is one slider window and two one-over-one windows on the south elevation (Figure 44). The east elevation has a single-entry door (Figure 45). The north elevation has no window or door openings and faces a poured concrete retaining wall (Figure 46). The west elevation consists of two one-over-one windows and a slider window (Figure 47).

Since there is no actual property record card for this building, the dates for changes to the building are unknown; however, it appears to the researchers that a larger gable roof structure was constructed and “placed” over the smaller original rectangular building, creating the incised walkway and explaining why there are two different types of metal siding used. The original windows have all been removed and replaced.

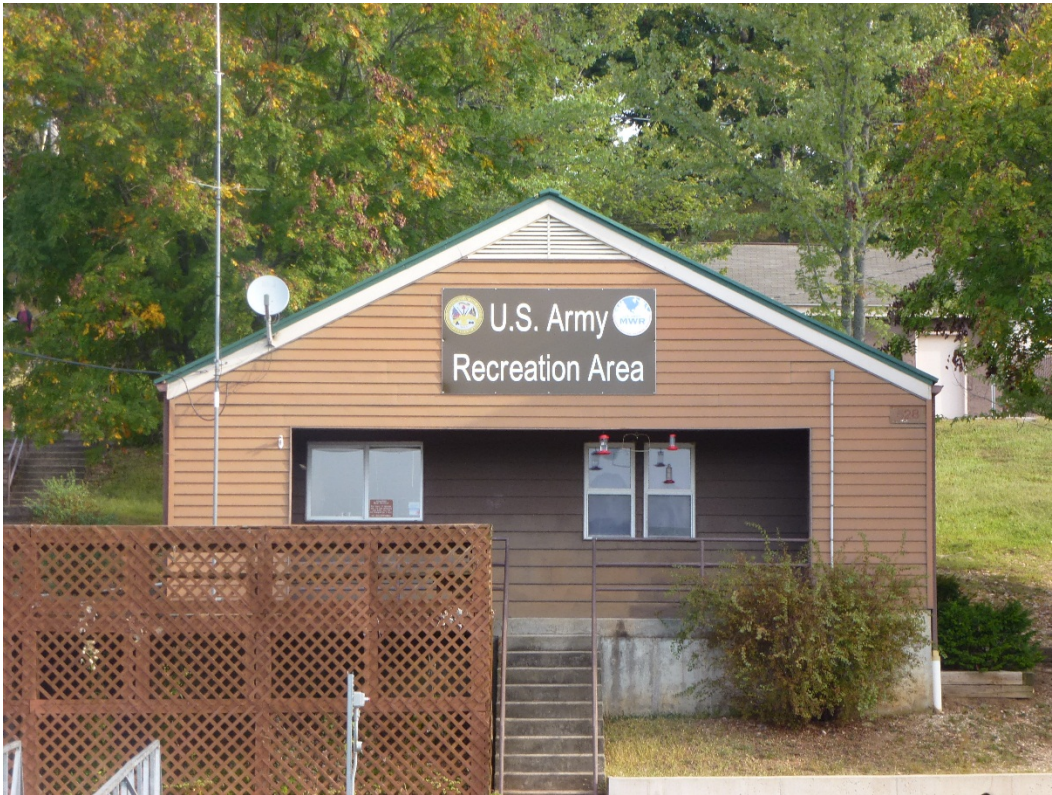
Figure 44. South elevation of Building 528 (ERDC-CERL, 2015).

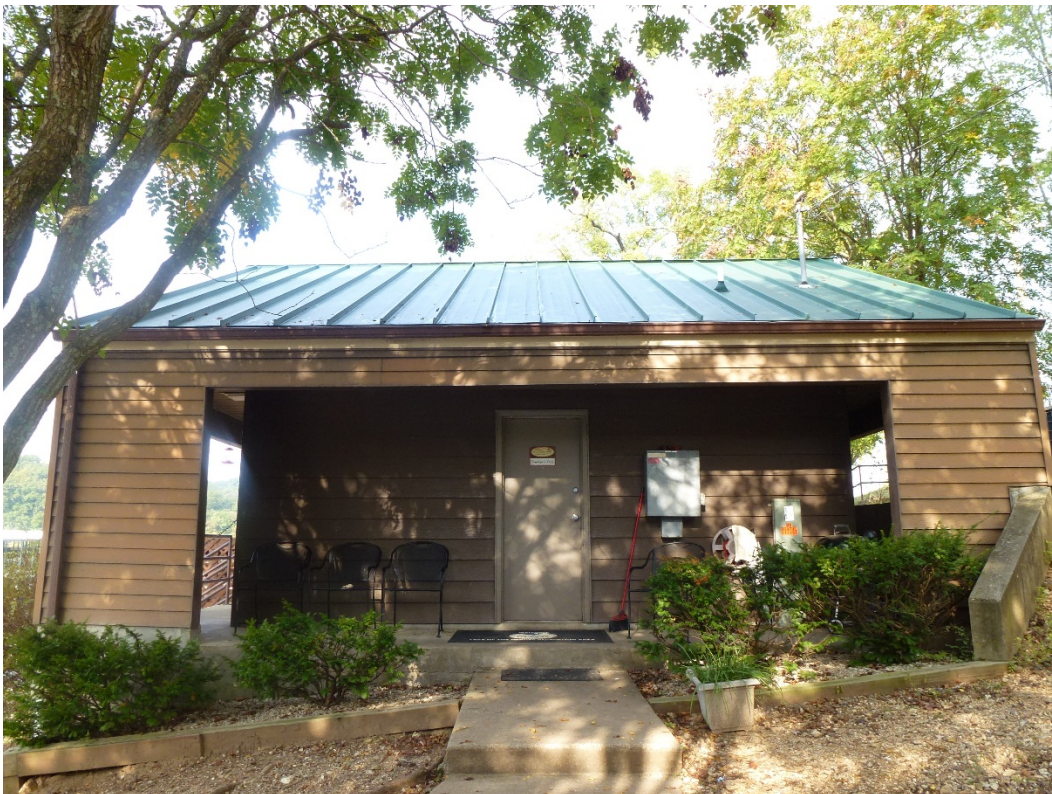
Figure 45. East elevation of Building 528 (ERDC-CERL, 2015).

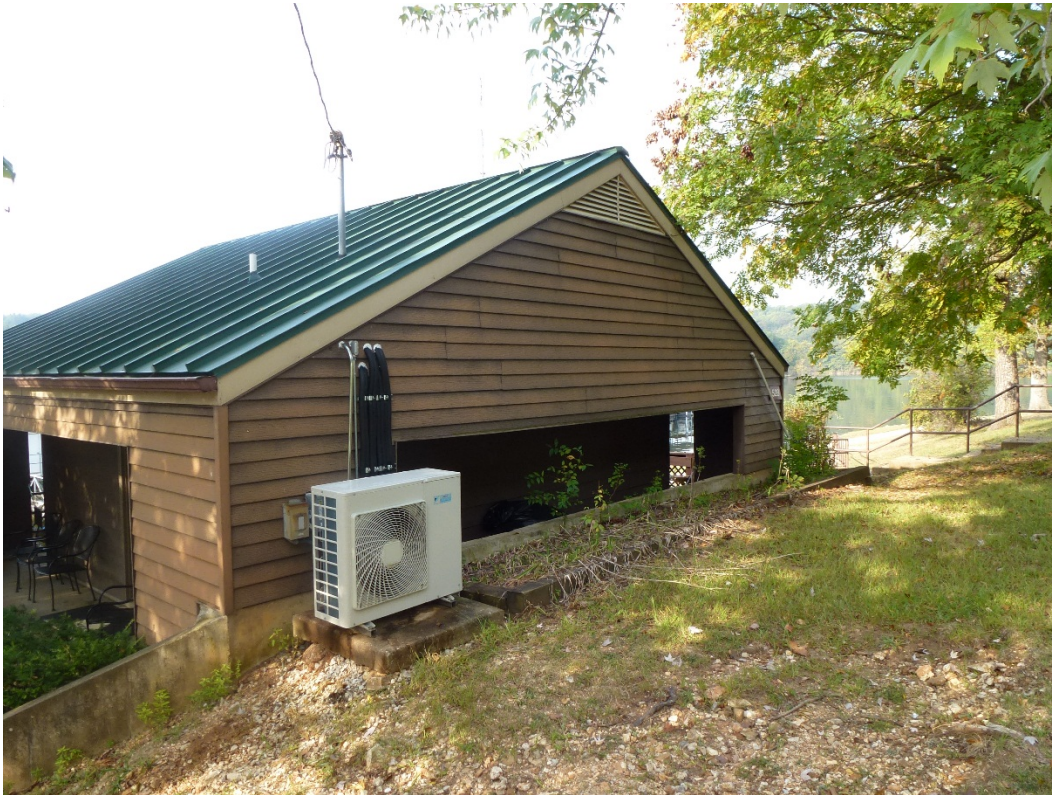
Figure 46. North elevation of Building 528 (ERDC-CERL, 2015).

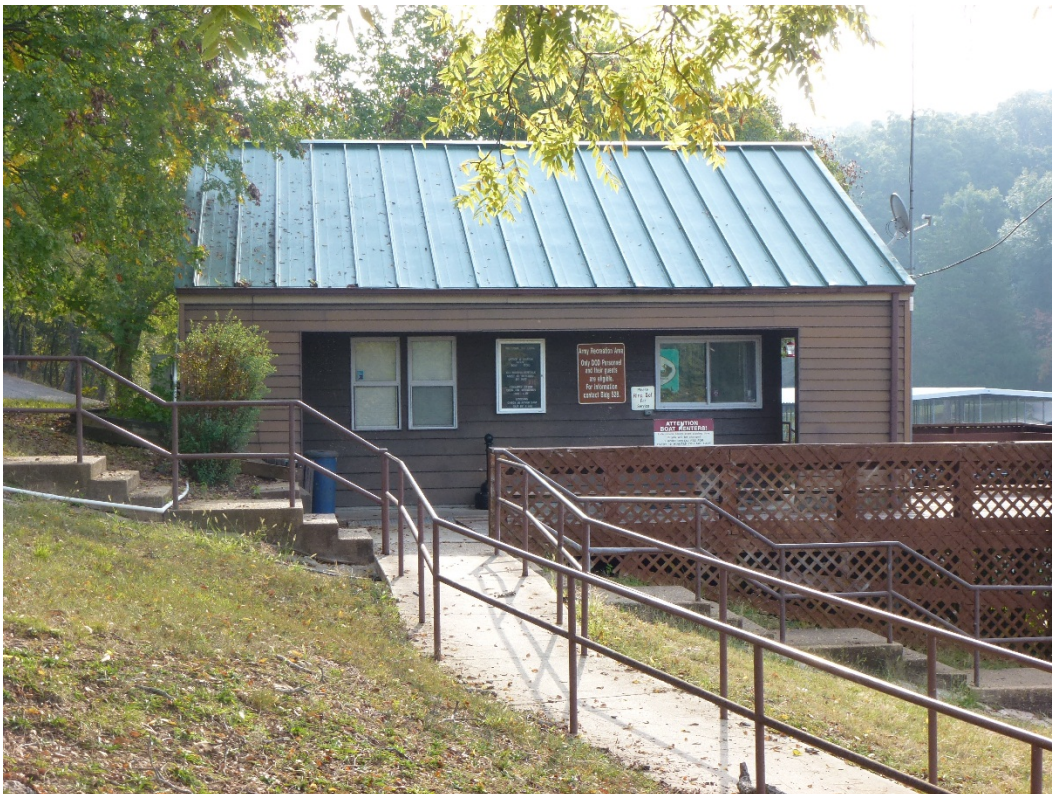
Figure 47. West elevation of Building 528 (ERDC-CERL, 2015).

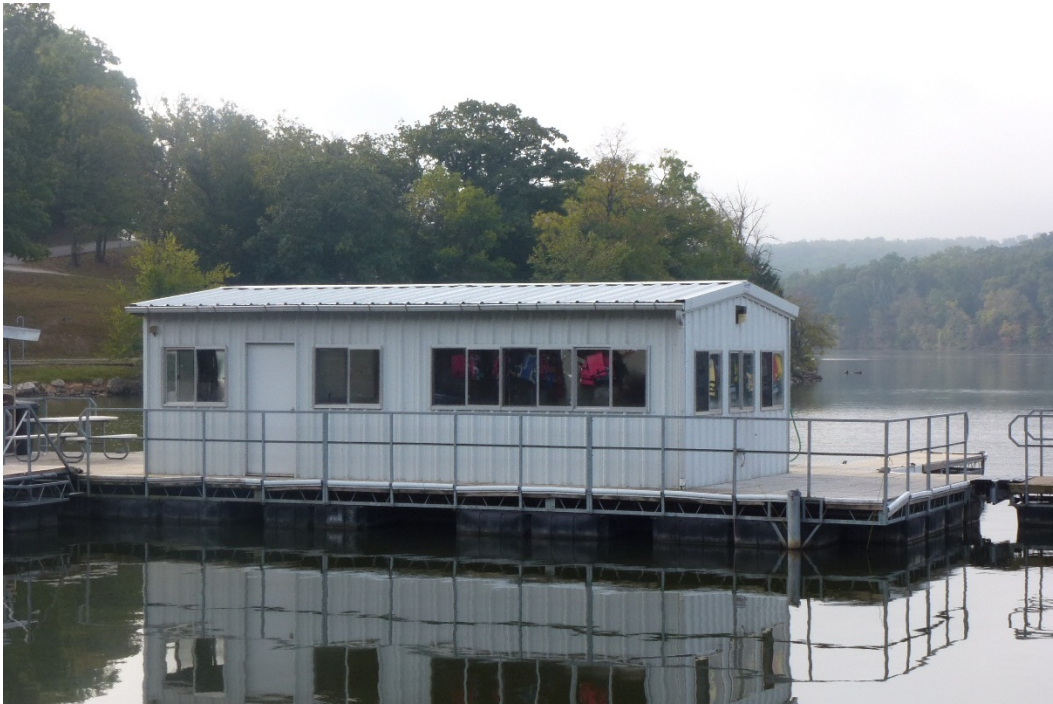
Figure 48. Northeast oblique of Building 537 (ERDC-CERL, 2015).

Building 537 actually sits on top of a floating dock that has three boat slips and two fueling pumps. Building 537 is a simple one-story rectangular structure with metal siding and a metal gable roof. The windows are metal-sash slider windows. The north and south elevations mirror each other, and each has two single slider windows, a ribbon of slider windows, and a single-entry door. The east and west elevations mirror each other, and each has three slider windows (Figure 48 and Figure 49).

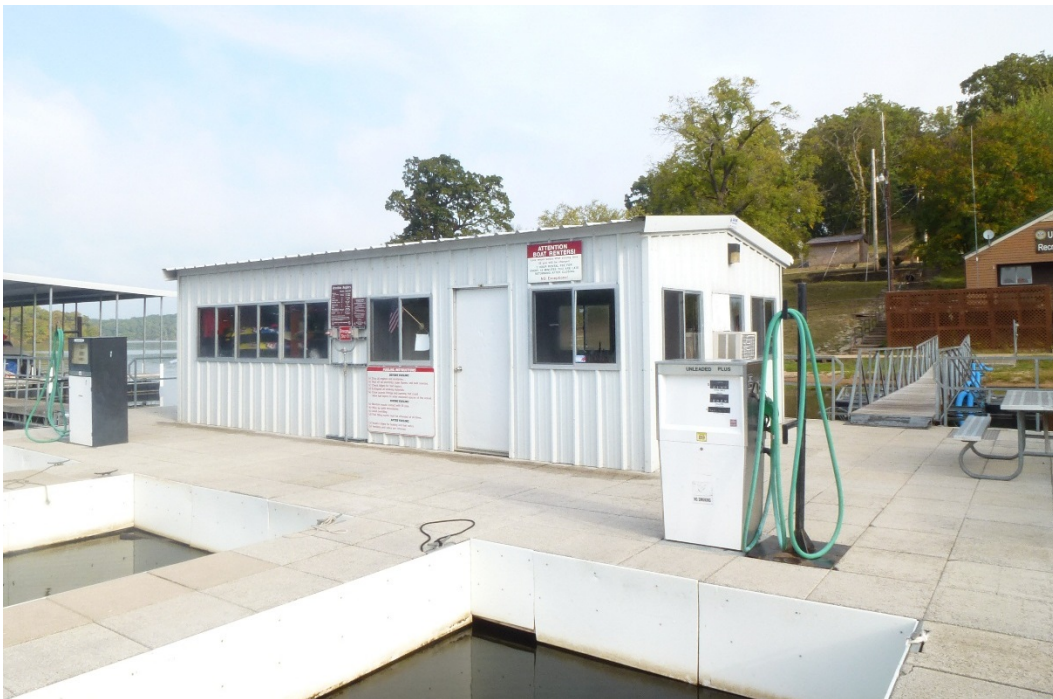
Figure 49. Southwest oblique of Building 537 (ERDC-CERL, 2015).

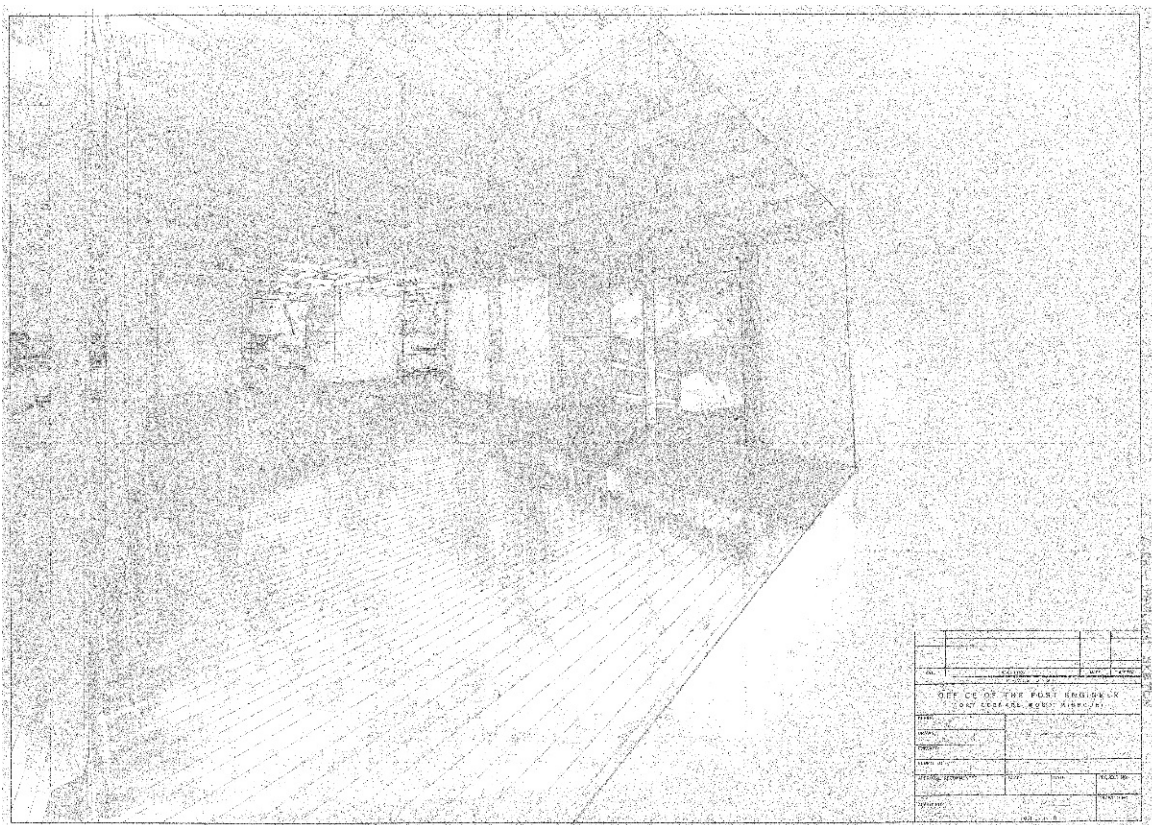
Figure 50. A sketch of the recreation pavilion to be located at LORA, 1960 (DPW, FLW).

Building 549 was constructed in 1961 as a recreation pavilion (Figure 50). It is currently used as the main recreation dock/pavilion to serve the

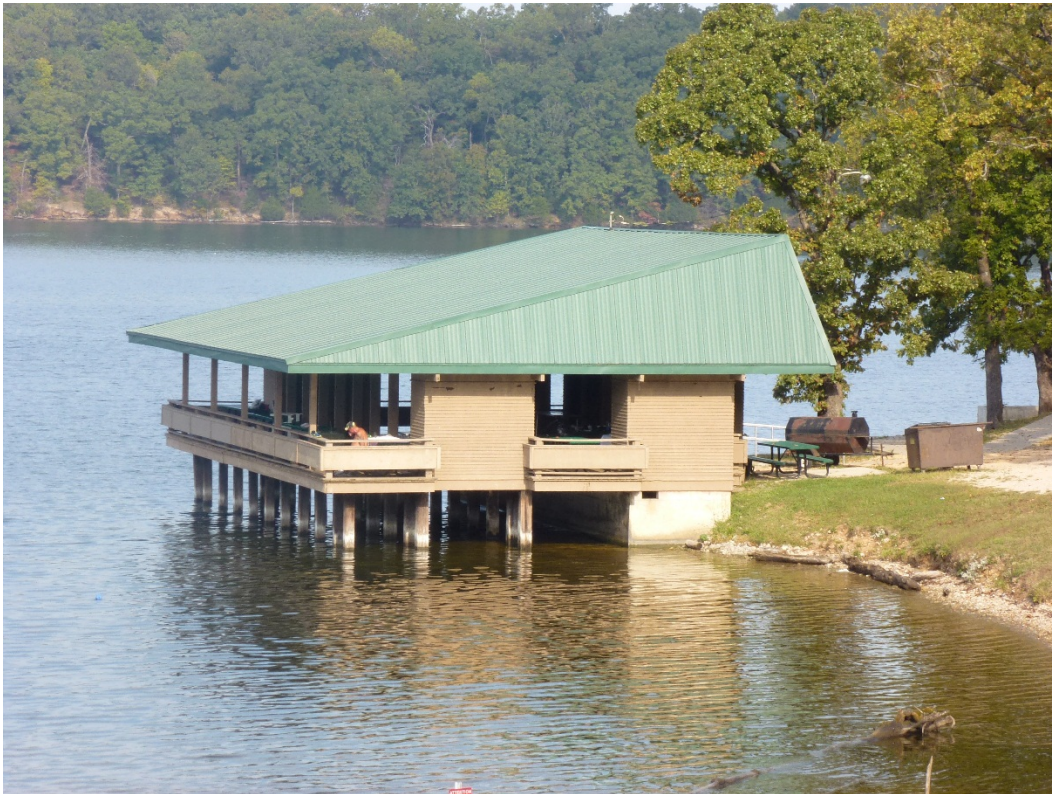
Figure 51. Looking at the southeast and southwest sides of Building 549, with the poured concrete foundation visible at the shoreline (ERDC-CERL, 2015).

Building 549 is a structure built on top of a concrete pier/wood-post foundation system, with the structure being anchored to the shoreline by a poured concrete foundation (Figure 51). The building is elevated over the lake. The building is an open-air structure that has partial wall enclosures on the northeast, southeast, and northwest sides (Figure 53 and Figure 56). The partial wall enclosures were designed as storage space and are clad with wood siding (Figure 56). Access to the shelter is from the northeast side, where there is a concrete sidewalk that leads to both a newer concrete ramp and direct access onto the platform for the shelter (Figure 54). The floor of the building is wood plank. The ceiling of the shelter is wood and is supported by wood columns (Figure 55). A wood-paneled safety wall wraps around three sides of the building, allowing for views to the lake (Figure 52). The roof is a hipped shed shape and is clad with newer metal roofing materials. It is unclear when this roof material modification occurred.

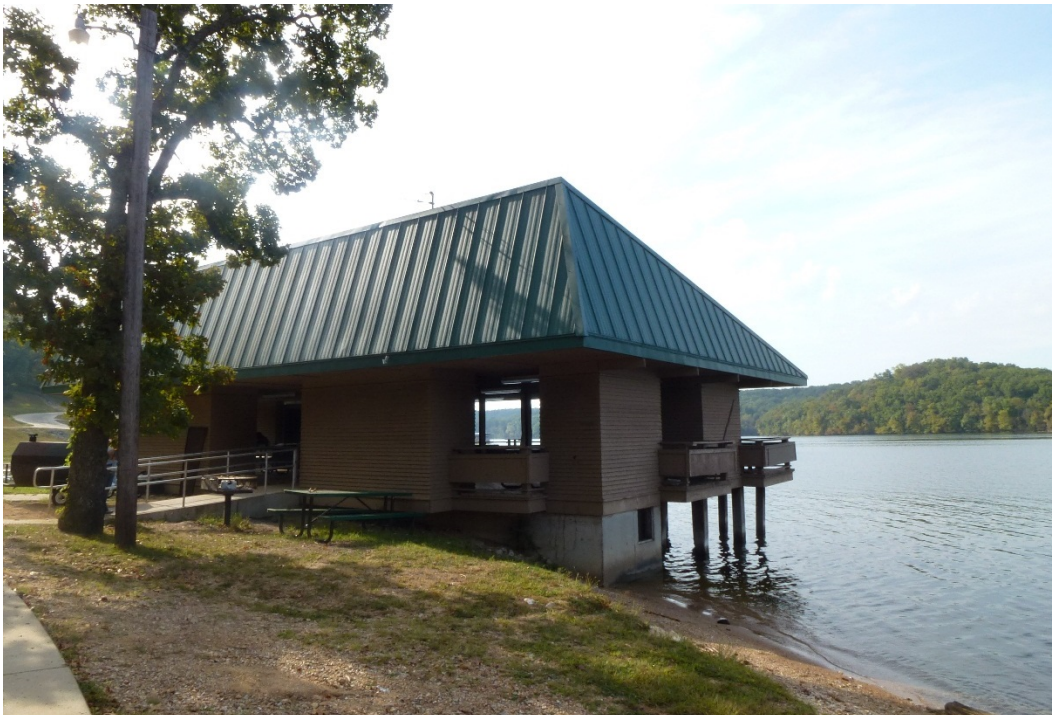
Figure 52. North oblique of Building 549 (ERDC-CERL, 2015).

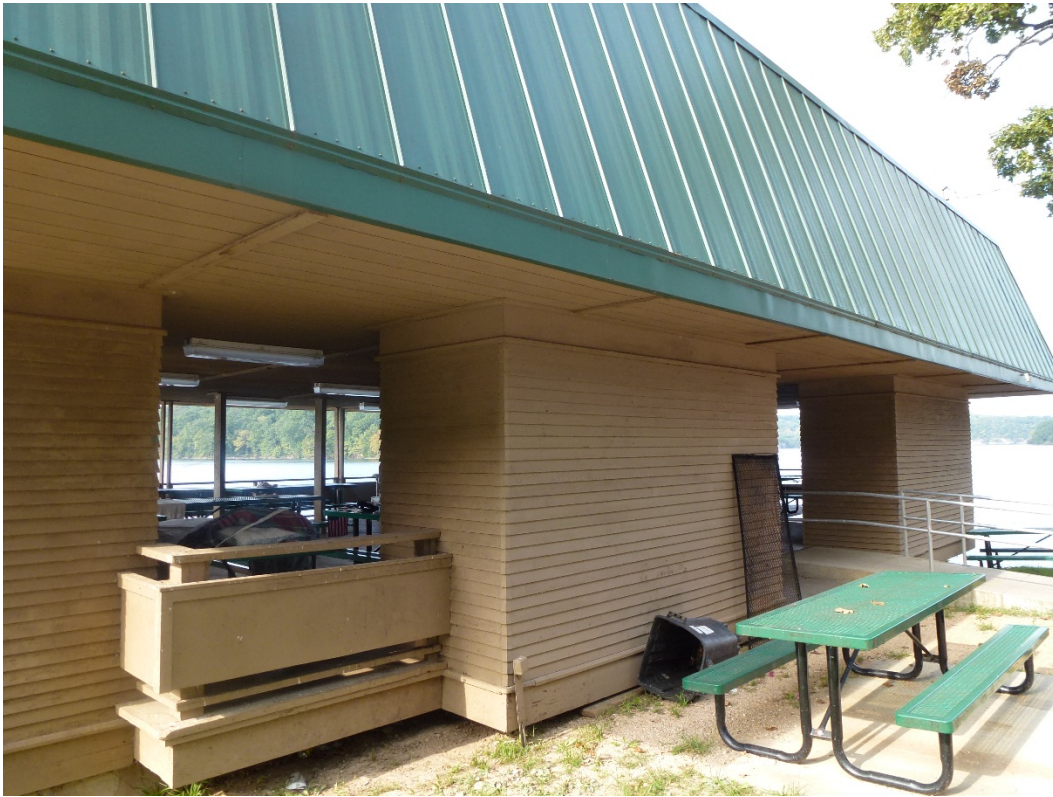
Figure 53. Northeast side of Building 549 (ERDC-CERL, 2015).

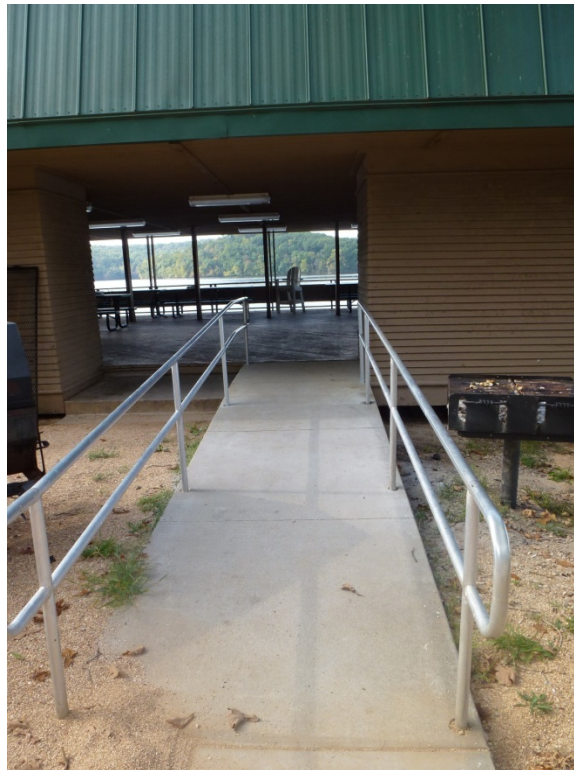
Figure 54. Newer concrete ramp on the northeast side of Building 549 (ERDC-CERL, 2015).

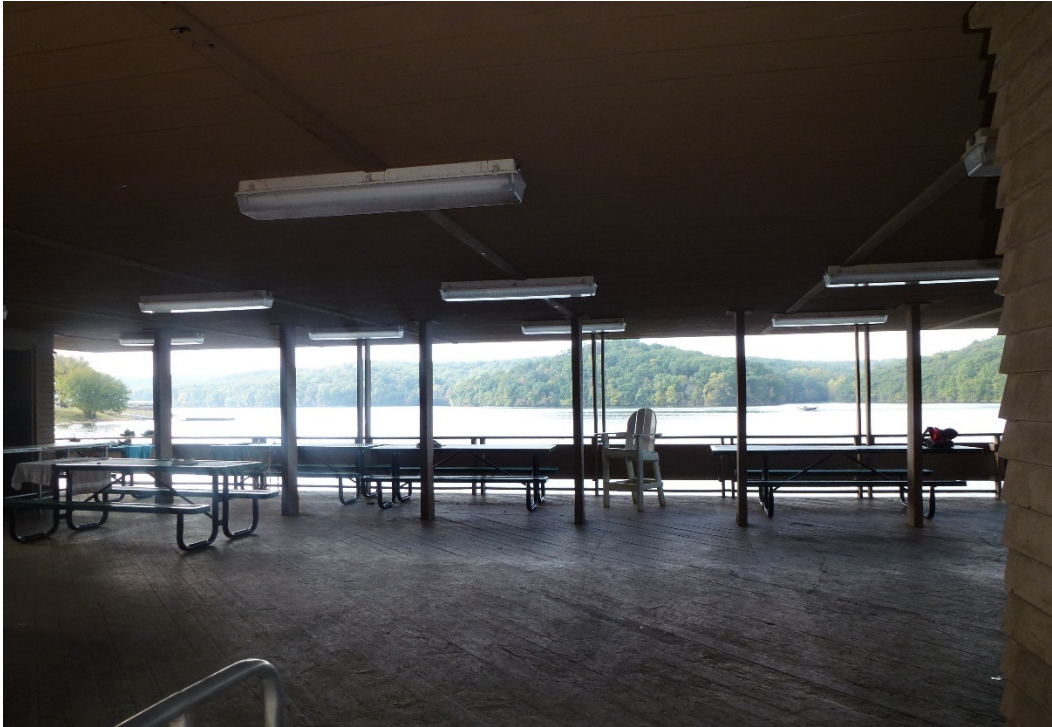
Figure 55. Interior view of Building 549 (ERDC-CERL, 2015).

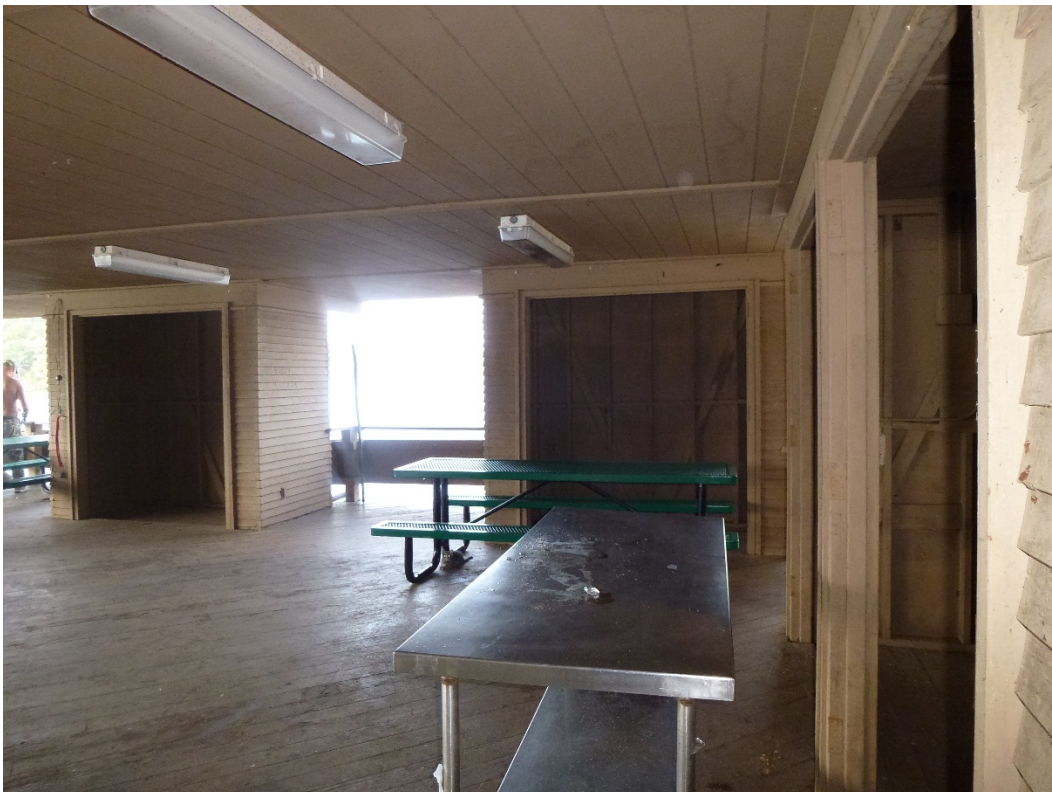
Figure 56. View of partial wall enclosures for the storage areas of Building 549 (ERDC-CERL, 2015).

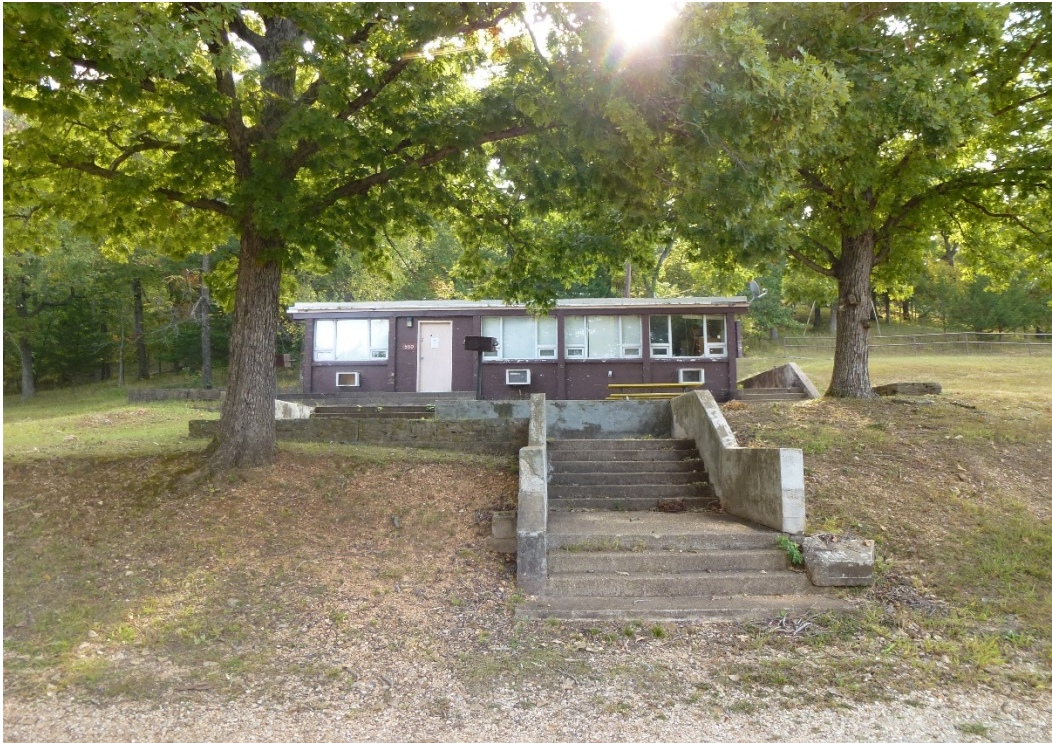
Figure 58. The concrete steps, retaining walls, and porch leading up to the south elevation of Building 550 (ERDC-CERL, 2015).

Building 550 was constructed in 1961, as the original Post Exchange (PX) building at LORA. At an unknown date, the building was converted into recreation billets. The building is located off a gravel road near the west shore of the LORA site (Figure 57). The building is positioned on the side of a hill overlooking the lake and the nearby helipad. A set of poured concrete steps with concrete retaining walls lead from the gravel drive up to the concrete porch in front of the building (Figure 58). Building 555 is just to the northeast.

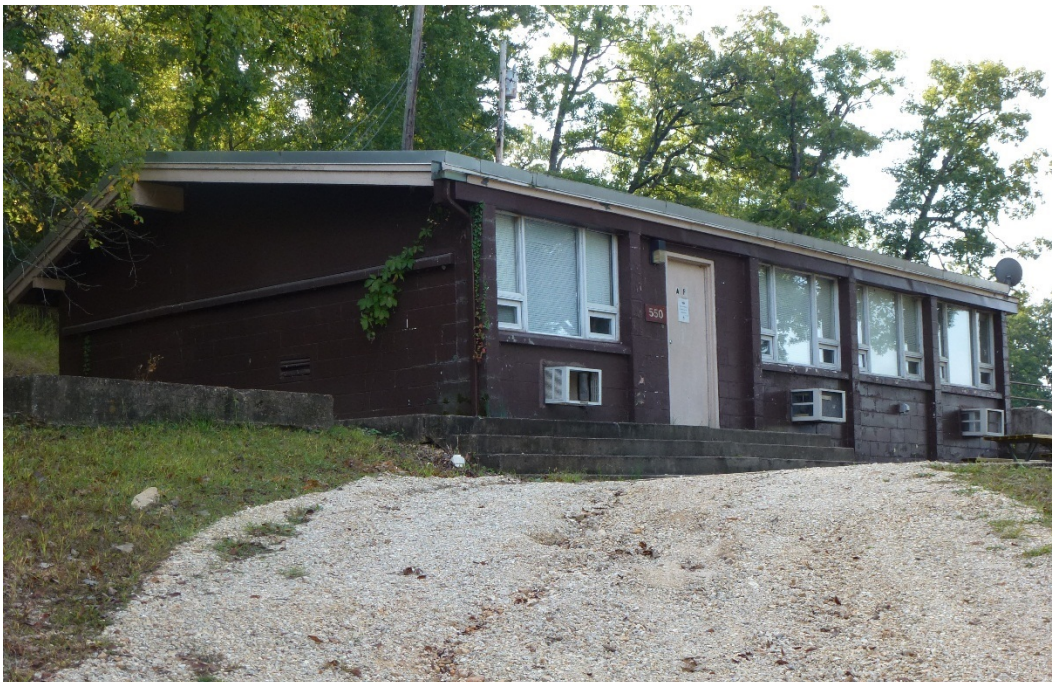
Figure 59. Southwest oblique of Building 550 (ERDC-CERL, 2015).

Building 550 is a small one-story structure with a rectangular footprint, a built-up gable roof with overhanging eaves with wood and metal fascia, concrete block exterior walls, replacement vinyl awning windows, and concrete windowsills. The south (front) elevation is divided into five bays by concrete pilasters (Figure 59). Four of the bays are each filled with a large window that is comprised of a single-pane fixed window in the middle that is flanked by a one-over-one awning window on either side (Figure 60). The fourth bay on the south elevation is filled with a single-entry door. The east and west elevations mirror each other. Each elevation has a large window opening nestled under the gable end that has been covered

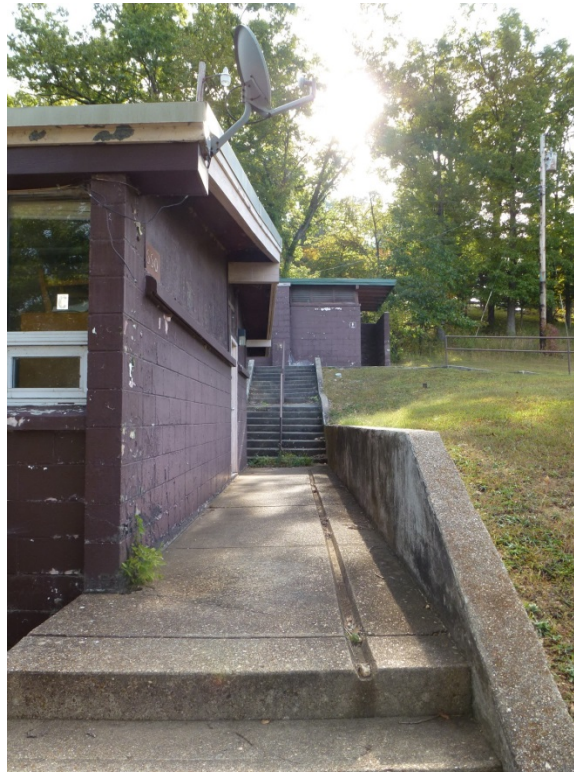
Figure 61. Concrete sidewalk, retaining wall, and steps on the east side of Building 550, leading to Building 551 (ERDC-CERL, 2015).

A poured concrete sidewalk with retaining wall runs along the east side of the building (Figure 61). The sidewalk connects Building 550 to Building 555. The north elevation faces the hill and another concrete retaining wall. A long narrow window opening located in the middle of the elevation has been covered with wood (Figure 62).

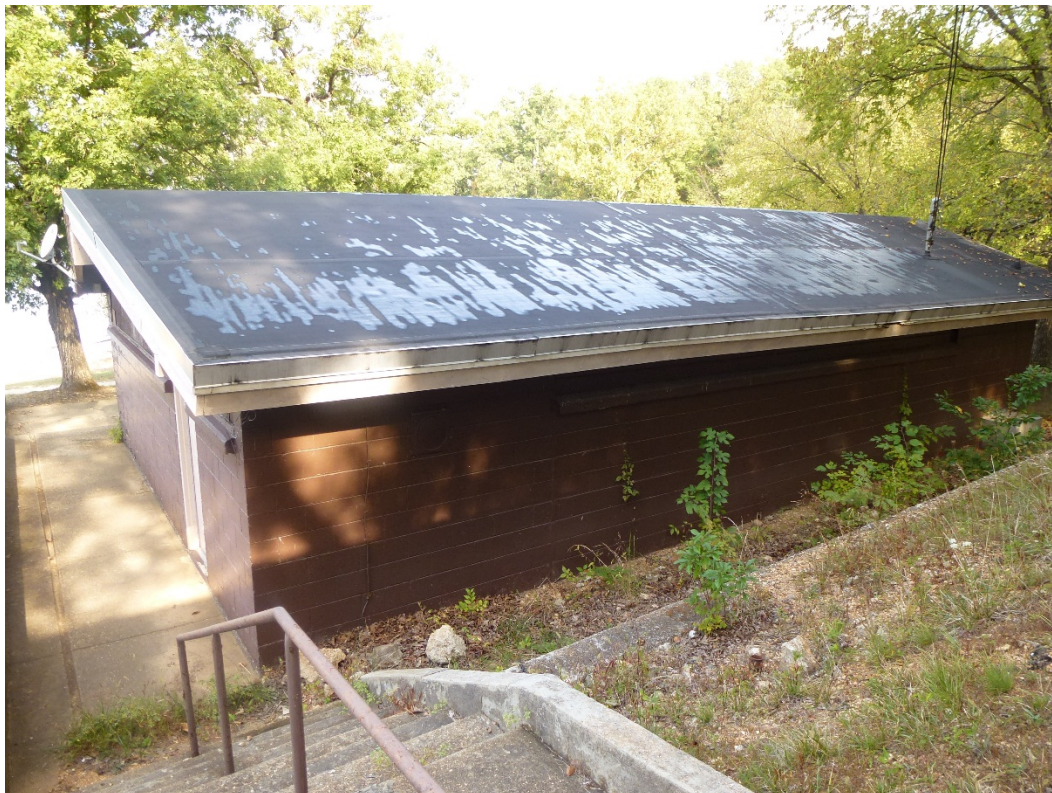
Figure 62. North elevation of Building 550 (ERDC-CERL, 2015).

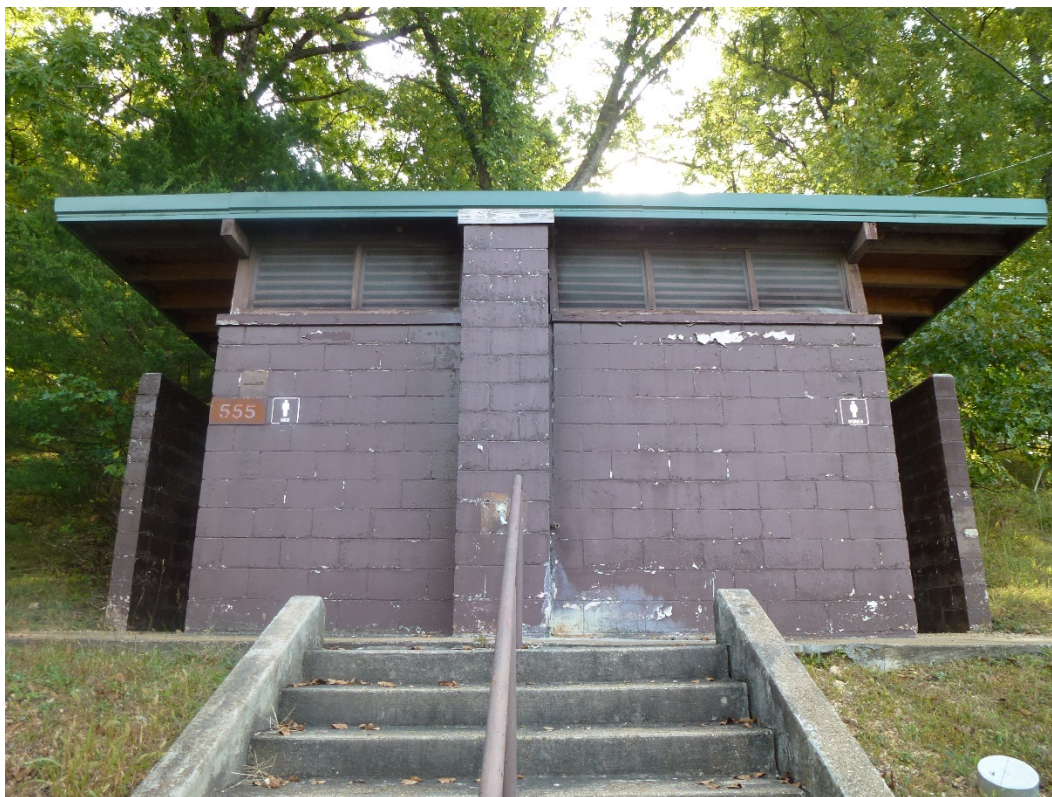
Figure 64. South elevation of Building 555 (ERDC-CERL, 2015).

Building 555 is a simple one-story structure with a rectangular footprint, a shallow built-up shed roof with overhanging eaves and exposed wood rafter supports, concrete block exterior walls, concrete windowsills, and a band of wood louvered screens located at the top of the walls. A set of poured concrete steps provide access to the building on the south side. The south elevation of the building is divided into two bays by a concrete pilas-

ter (Figure 64). The top of the wall is filled with wood louvered vents that are covered with a mesh screen. The east and west elevations mirror each other. Each elevation consists of a single-entry door and the same band of louvered vents at the top of the wall. In front of each of these elevations is a concrete block privacy wall. The roof overhangs protect the sidewalk between the building's exterior wall and the privacy wall on these elevations (Figure 65). The north elevation is nestled into the hill, and the same types of louvered vents are located at the top of the wall.

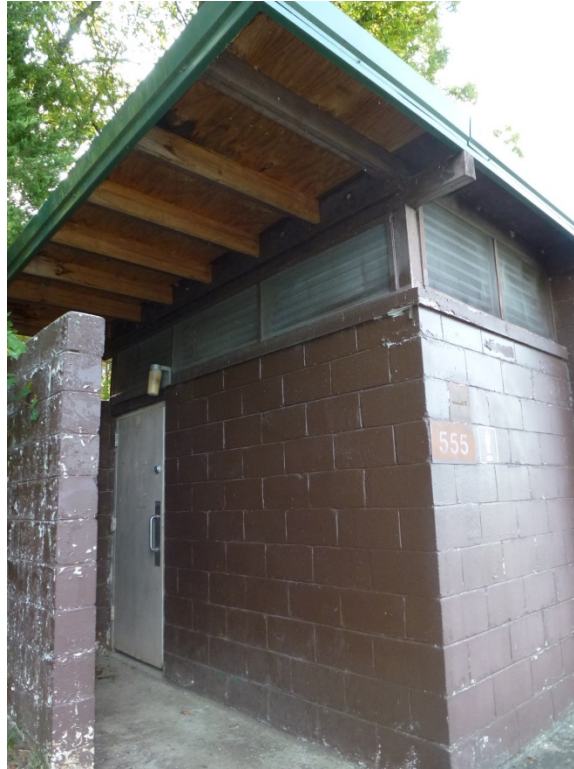
Figure 65. West elevation of Building 555 (ERDC-CERL, 2015).

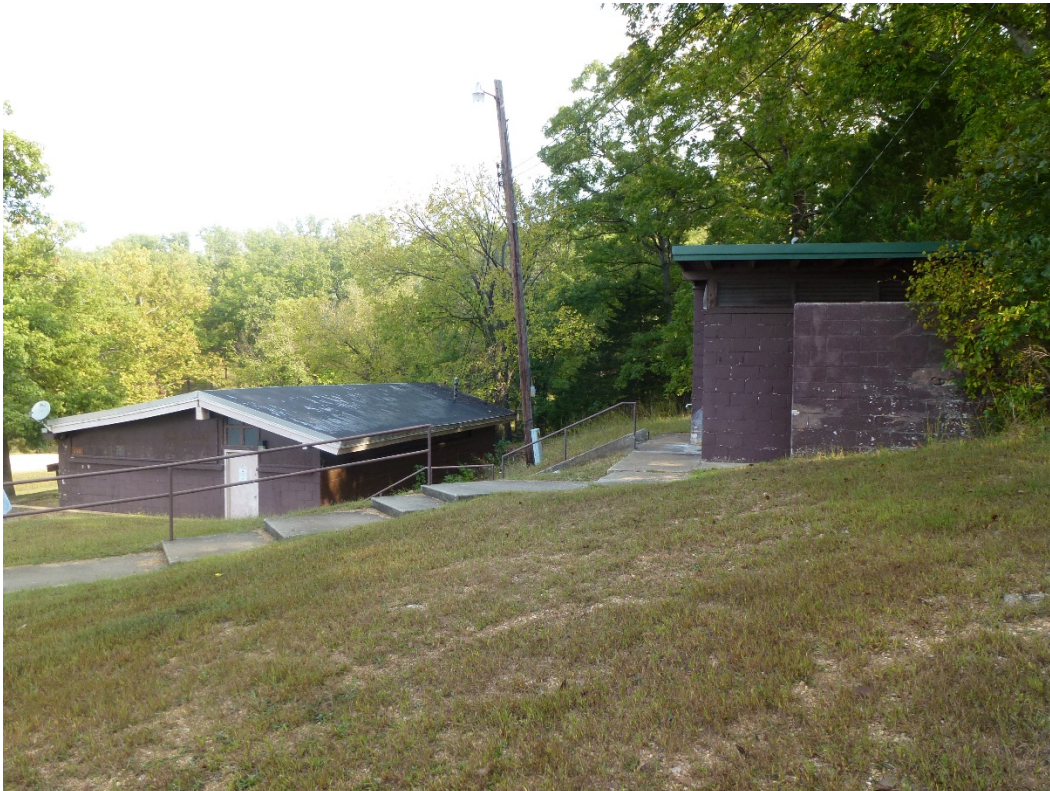
Figure 66. View of the relationship of Buildings 550 [left] and 555 [right], east elevation (ERDC-CERL, 2015).

Building 555 was constructed in 1961 as a toilet/shower facility. It is currently vacant. The building is located off a gravel road near the west shore of the LORA site. The building is positioned on the side of a hill overlooking the lake and the nearby helipad (Figure 63). A set of poured concrete steps with concrete retaining walls leads from the gravel drive up to a concrete porch in front of the building. A separate poured concrete stair/sidewalk with metal handrails leads from the south side of the building down to the road and the helipad. Building 550 is just to the southwest (Figure 66).

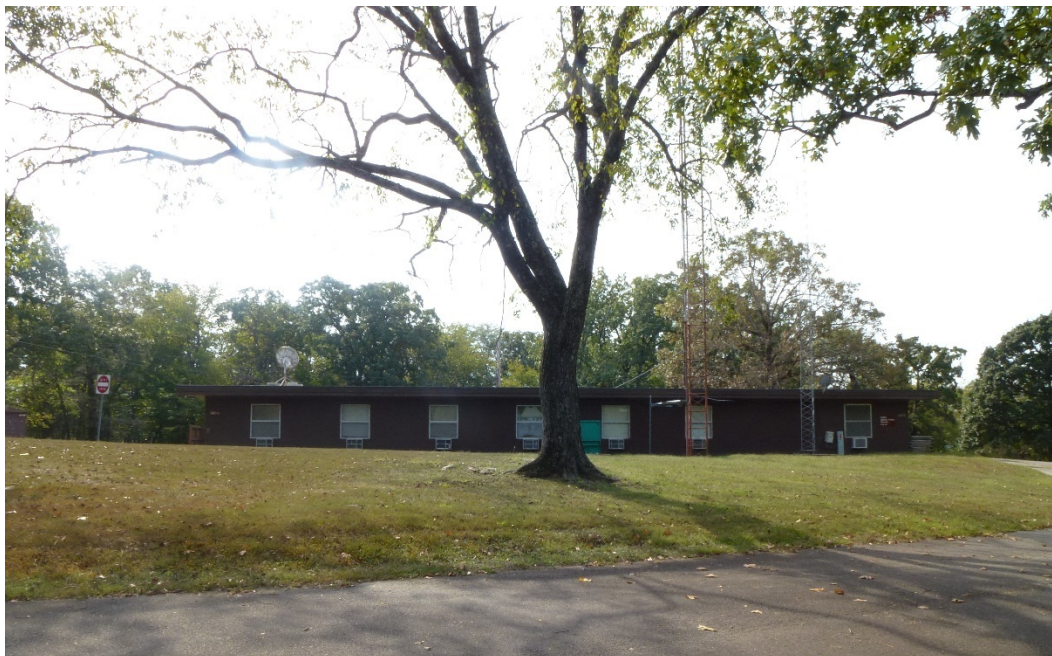
**Figure 68. North elevation of Building 560 (ERDC-CERL, 2015).**

The north elevation faces Olney Circle. There are seven one-over-one windows on this elevation (Figure 68 and Figure 69). The east elevation is two-part: the right side projects outward and there is a single-entry door and a smaller original metal-sash one-over-one window on this part of the elevation, and the left side is recessed with a small narrow slider window on that portion of the wall (Figure 70). The middle section of the south elevation projects outward from the left and right sides (Figure 71).

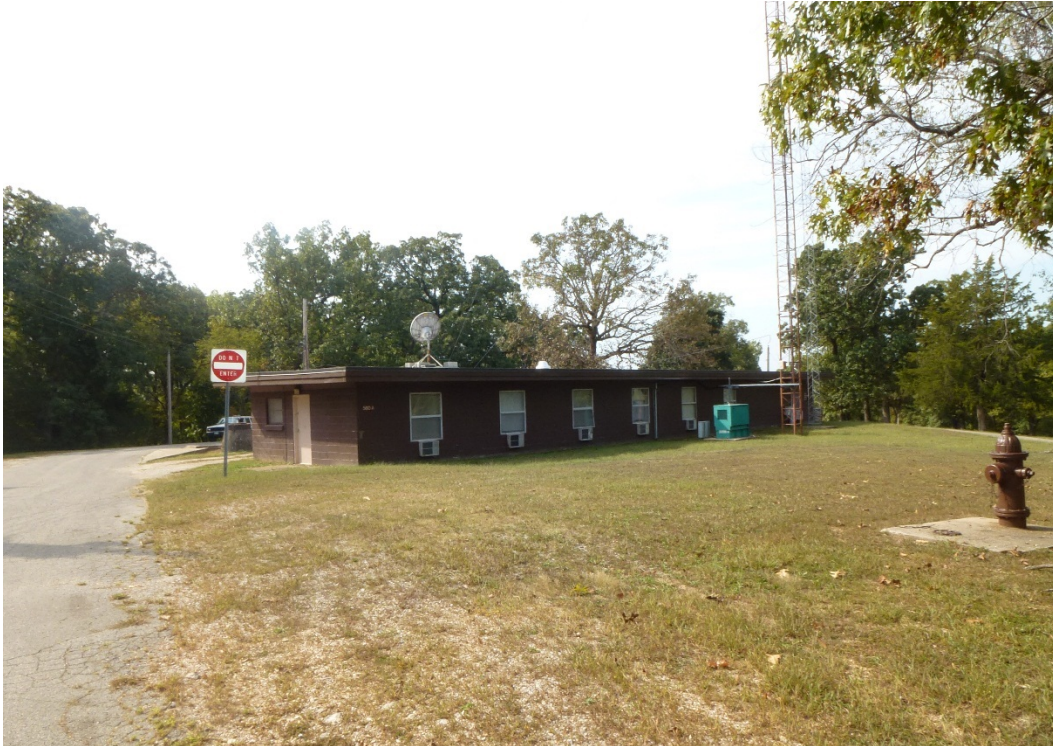
Figure 69. Northeast oblique of Building 560 (ERDC-CERL, 2015).

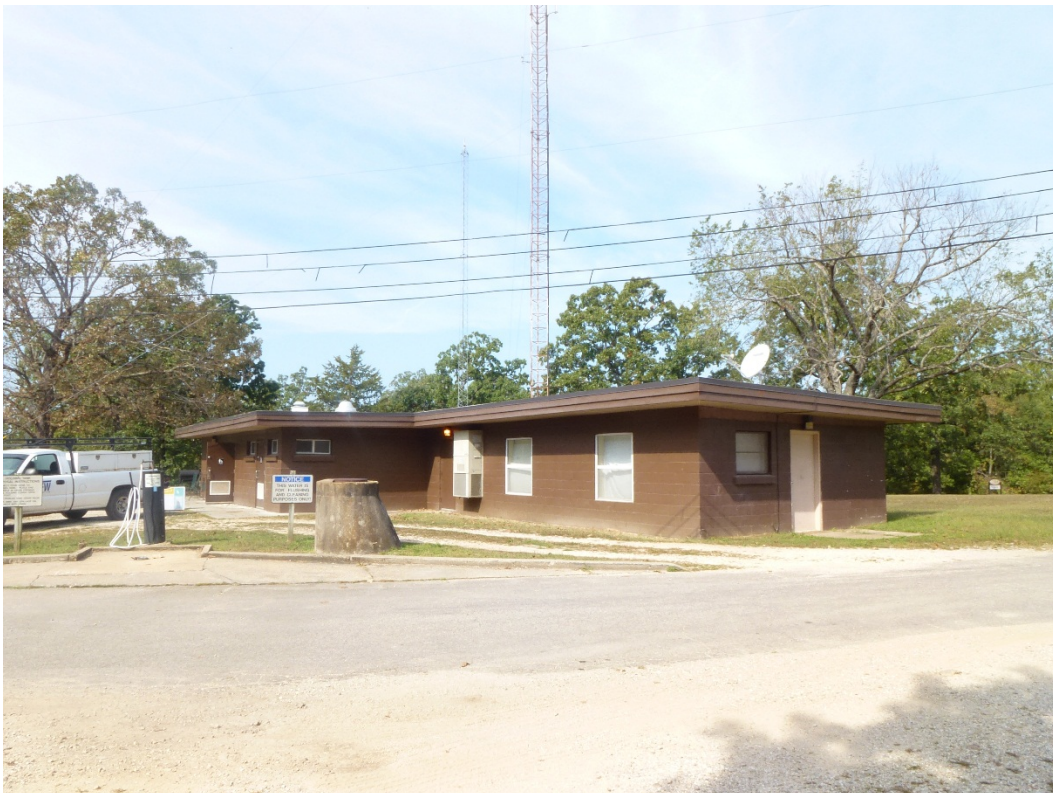
Figure 70. Southeast oblique of Building 560 (ERDC-CERL, 2015).

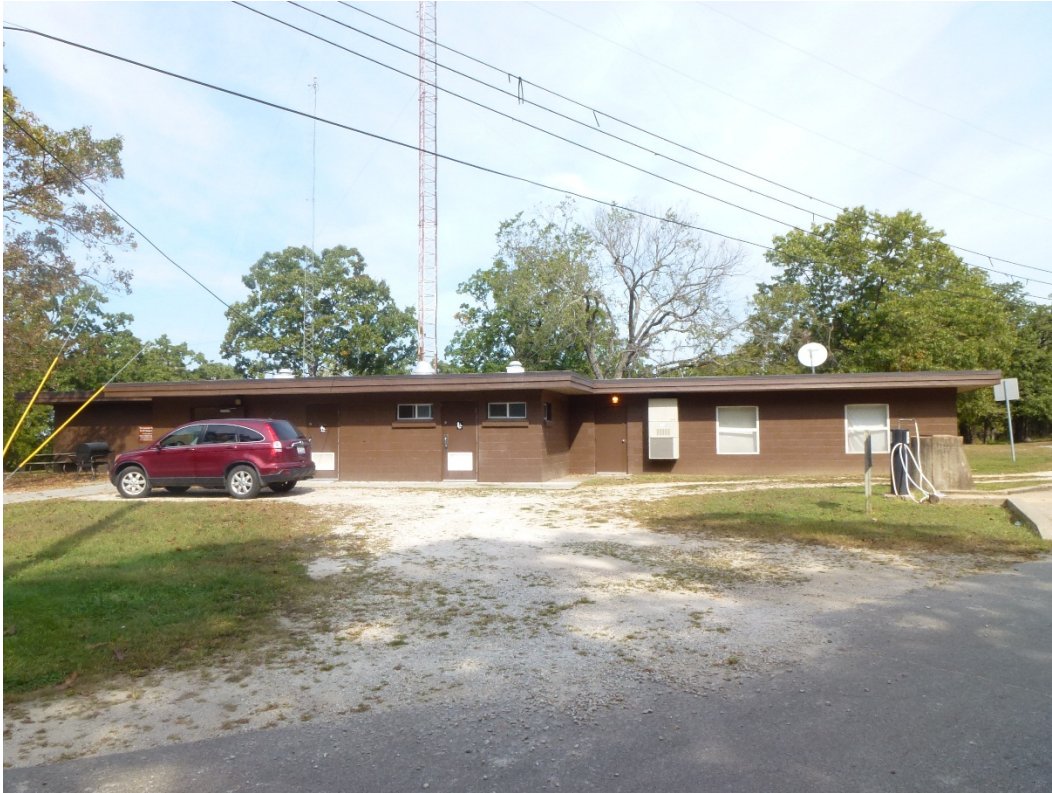
Figure 71. South elevation of Building 560 (ERDC-CERL, 2015).
